# Lower Colorado River Multi-Species Conservation Program

## Backwater Inventory: Reaches 5 & 6 Step 1: Identification of Backwaters for Screening and Evaluation

## **Backwater Inventory: Reaches 5 & 6**

### **Step 1: Identification of Backwaters for Screening and Evaluation**

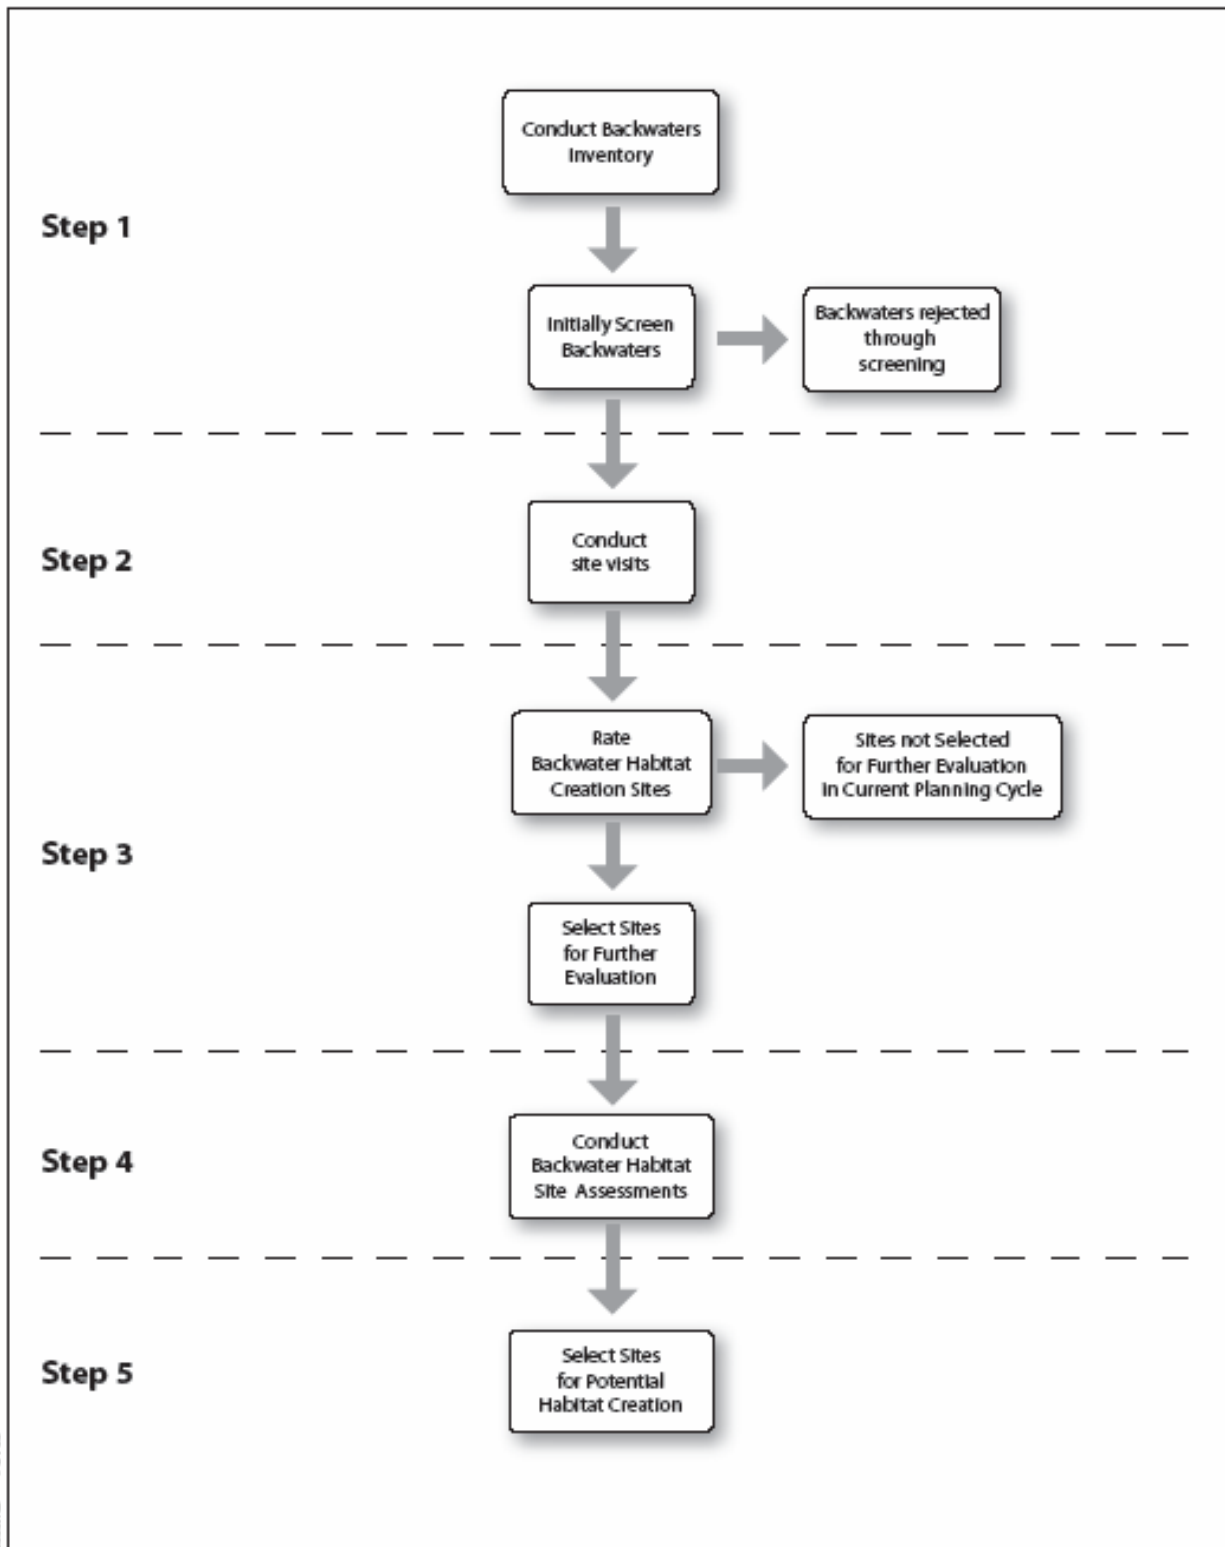
**Figure 1. Site-Selection Process for Backwaters**

In 2006, the Bureau of Reclamation (Reclamation) completed *Draft Final Guidelines for the Screening and Evaluation of Potential Conservation Areas* (Reclamation 2006), which detailed a five-step process that the Lower Colorado River Multi-Species Conservation Program (LCR MSCP) will use to screen and evaluate potential backwater land cover types (LCR MSCP 2006). During Step 1, Reclamation is tasked with inventorying and initially screening backwaters to identify approximately 25 candidate backwaters for further screening and evaluation. The five-step process is summarized in Figure 1.

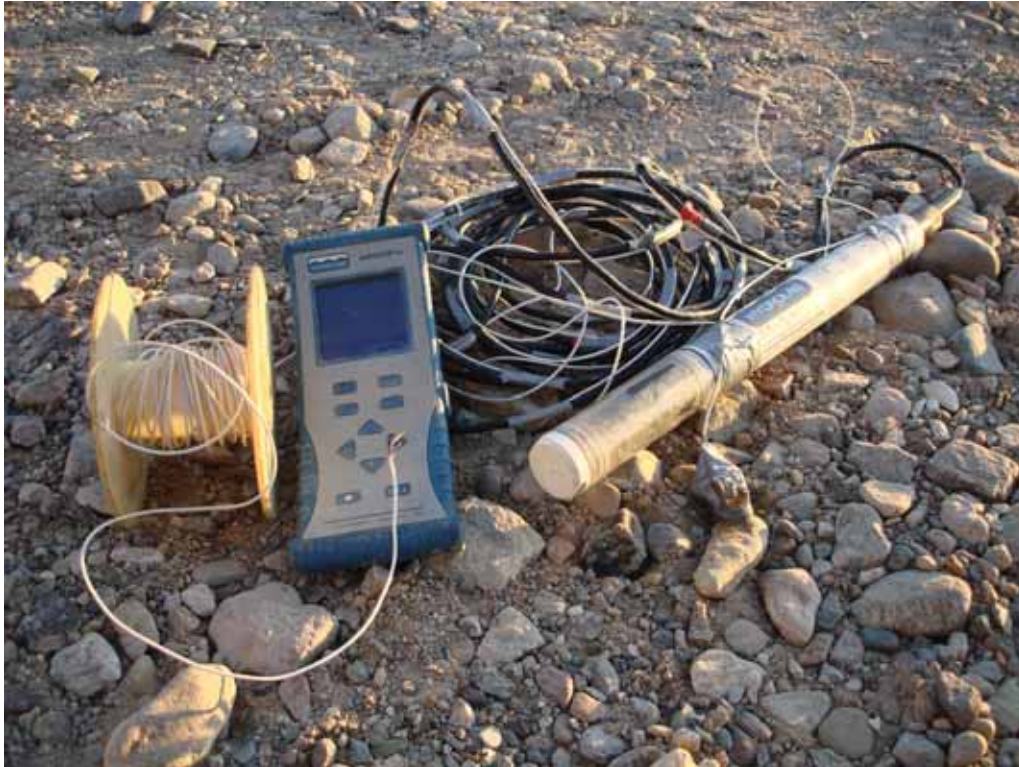
**Figure 3. Hydrolab minisonde modified with grounding wire for aerial sampling**

established using the Hydrolab's internal depth sensor. Aerial Hydrolab sampling required attaching a grounding wire to the frame of the helicopter to discharge built-up static electricity, which may have otherwise damaged the equipment (Figure 3).

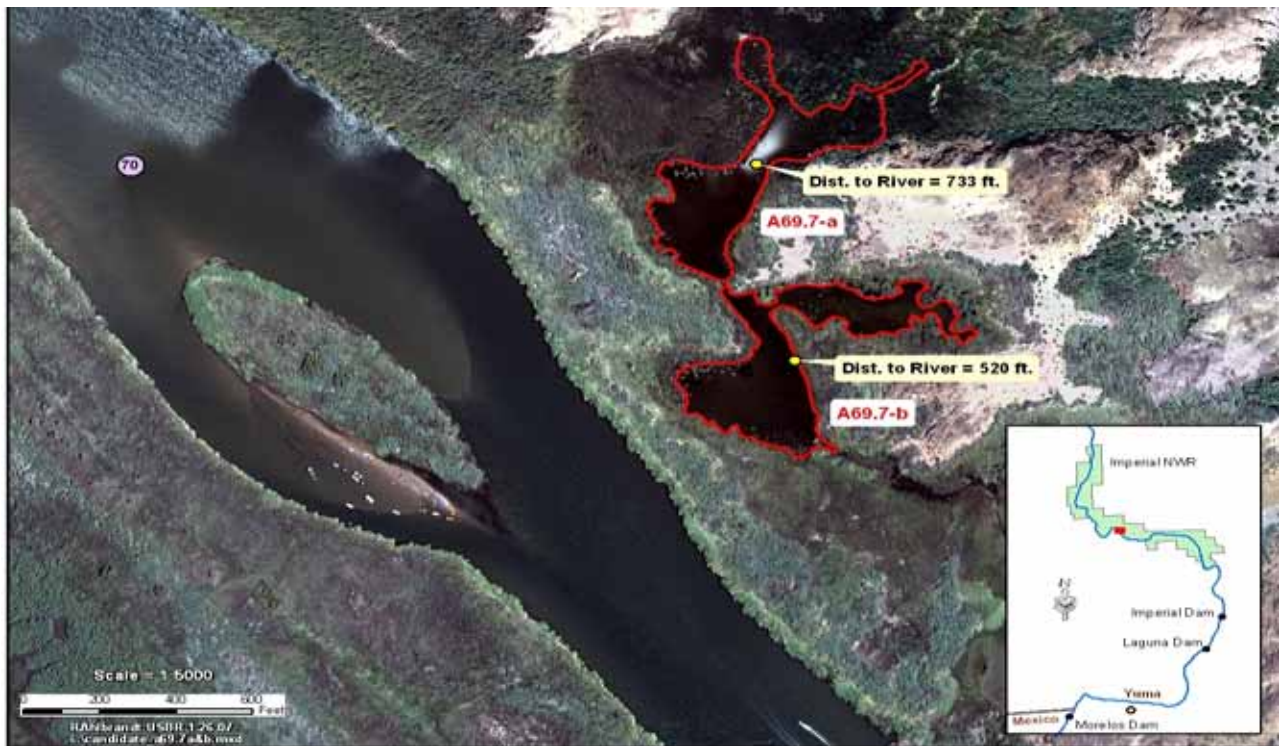
Norton Lake consists of two indirectly connected backwaters (3.6 ac each) on the Arizona side of the Colorado River at river mile 69.75. These two backwaters could potentially be expanded and connected into one, managed independently, or connected without expansion. Water clarity extended to the bottom, and water quality conditions were similar to that of the Colorado River (based on visual and hydrolab observations taken by helicopter). Because this backwater exhibited similar water quality conditions to the river without a visible surface connection, it is classified as a pseudo-seep.

Site access to this backwater is virtually nonexistent from the river or land. Norton Lake is within a designated wilderness area, which would likely prevent the construction of any new roads for site access outside of the floodplain; heavy equipment access would be by river only. Public access is not restricted; however, no people were observed at Norton Lake at the time of the helicopter survey.

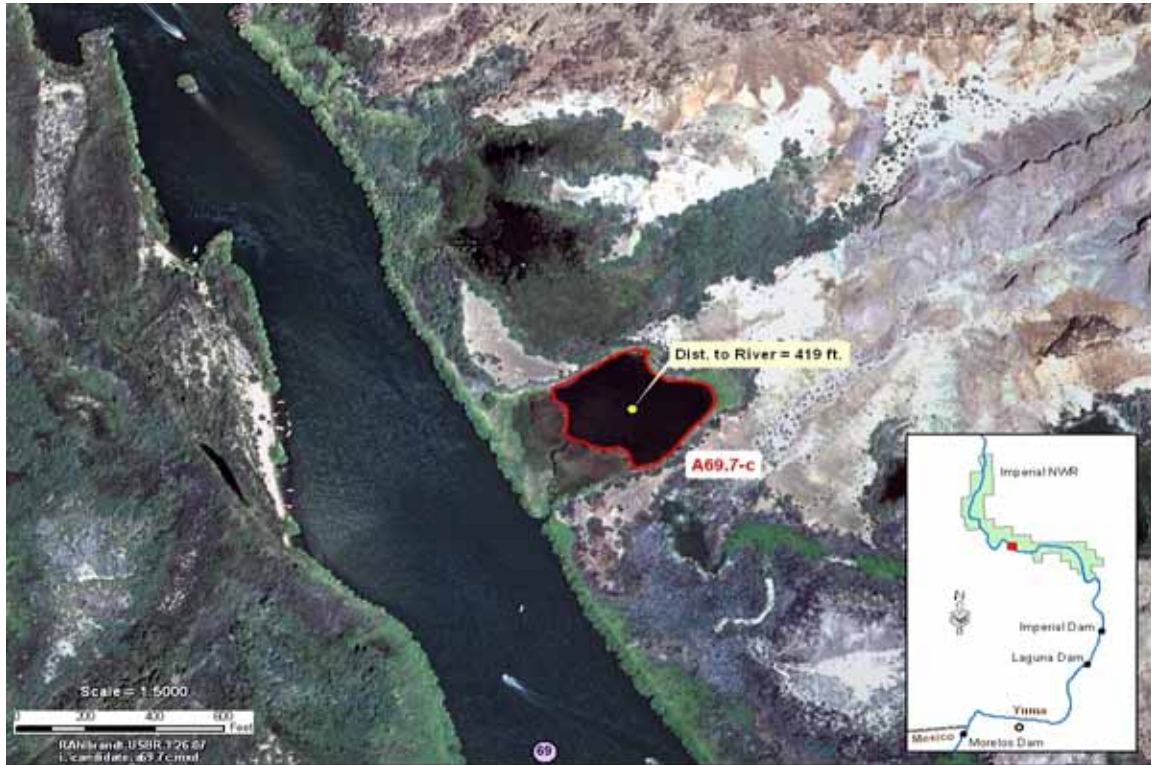
A69.7c is a directly connected backwater (2.4 ac) on the Arizona side of the Colorado River at river mile 70. The backwater is connected to the river via a small inlet channel.

Water quality in A69.7c was very similar to the Colorado River. Water clarity was good to moderate. Because of the similarities in water quality based on water quality profiles, as well as the observed connection to the river, A69.7c is classified as a connected lake.

Site access to A69.7c is limited. There appears to be access by kayak or small jon boat via a small inlet to the river. In addition, a trail was observed from the backwater to the river.

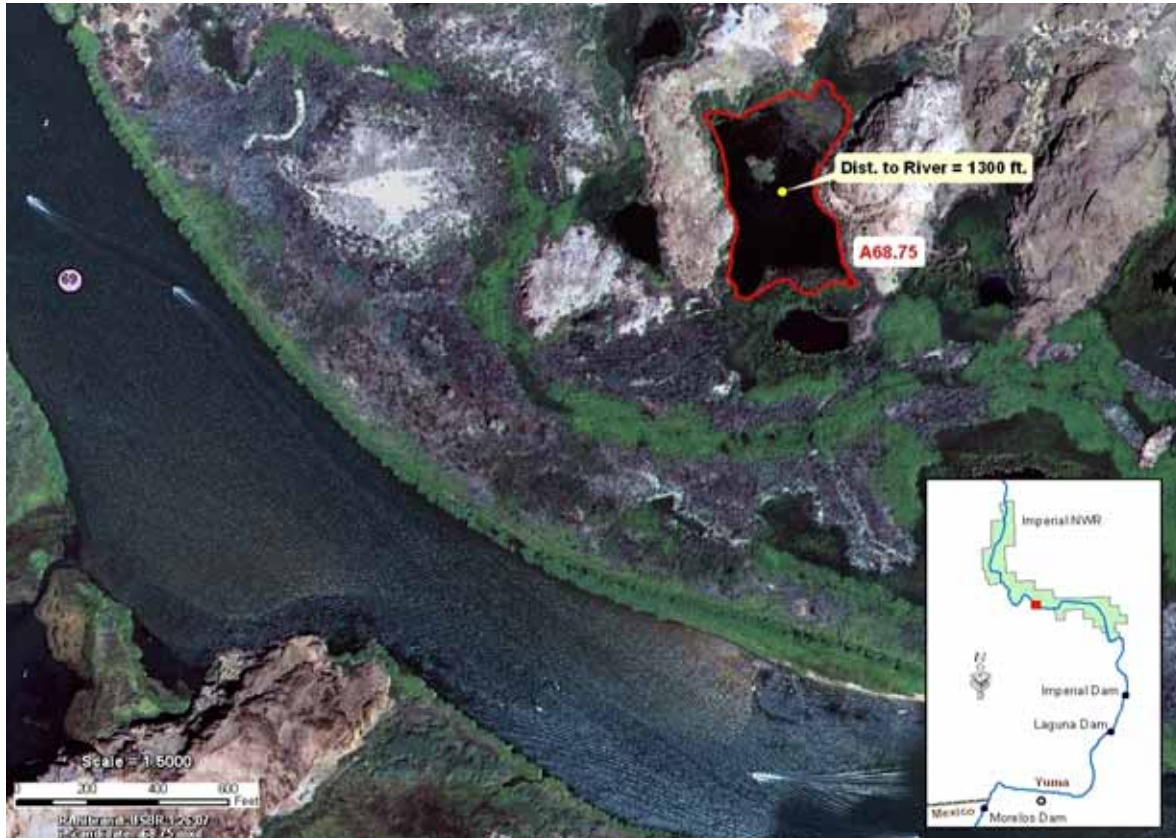
A68.75 is an indirectly connected backwater (4.0 ac) on the Arizona side of the Colorado River at river mile 68.

High salinity was identified as an issue that would need to be addressed; however, it appears that it may be possible to connect this backwater to the river. Water clarity was moderate. Based on a water quality profile conducted here, this backwater exhibited drastically higher salinity than the river without a visible surface connection. It is classified as a true seep.

This backwater is well isolated, virtually without site access from the river or land. A68.75 is within a designated wilderness area, which would likely prevent the construction of any new roads for site access outside of the floodplain; heavy equipment access would be by river only. Public access is not restricted; however, no people were observed at A68.75 at the time of the helicopter survey.

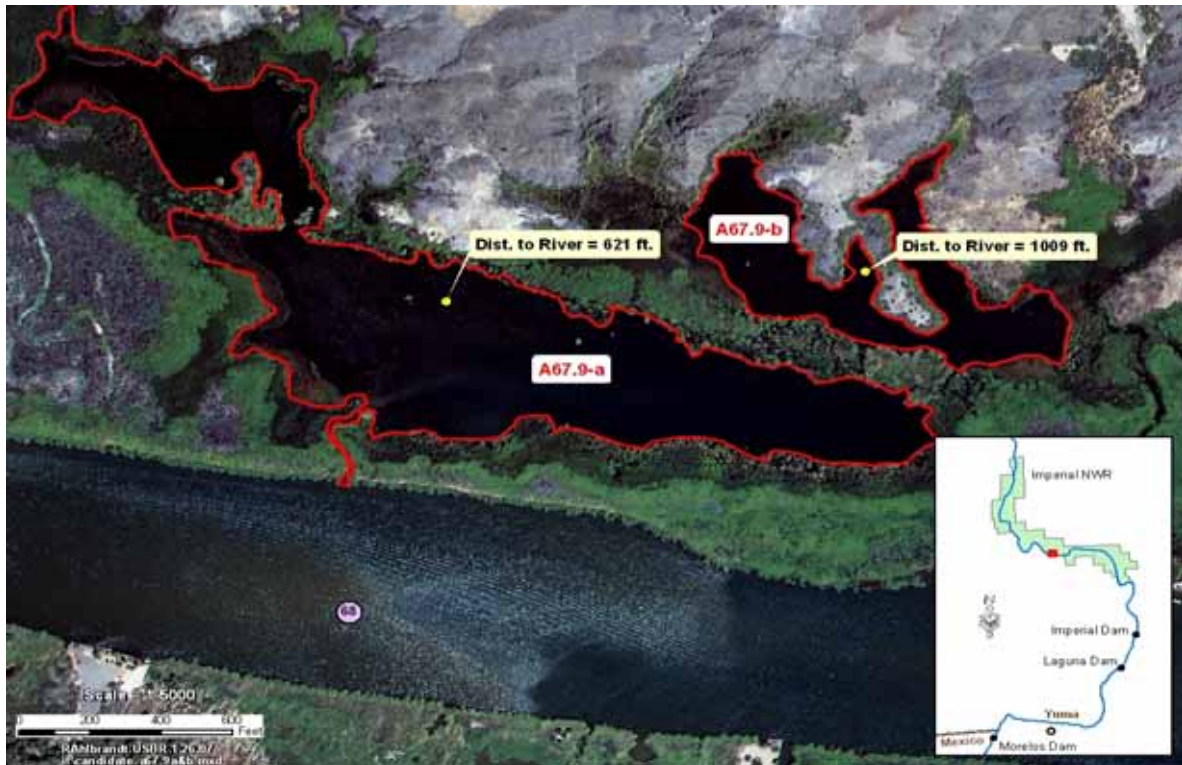
Hidden Lake consists of two directly connected backwaters (21.9 and 6.9 ac) on the Arizona side of the Colorado River at river mile 68. These two backwaters could potentially be connected and then isolated from the river, or be managed as two separate backwaters.

Water quality in Hidden Lake is likely very similar to the Colorado River; however, no water quality profiles were performed. Water clarity extended to the bottom. Because of the observed surface connection to the river, Hidden Lake is classified as a connected lake.

The only known site access to Hidden Lake may be via a small channel from the river. The backwater is within a designated wilderness area, which would likely prevent the construction of any new roads for site access outside of the floodplain; heavy equipment access would be by river only. Public access is not restricted; however, no people were observed at Hidden Lake at the time of the helicopter survey. Determining recreational use at Hidden Lake would require additional effort.

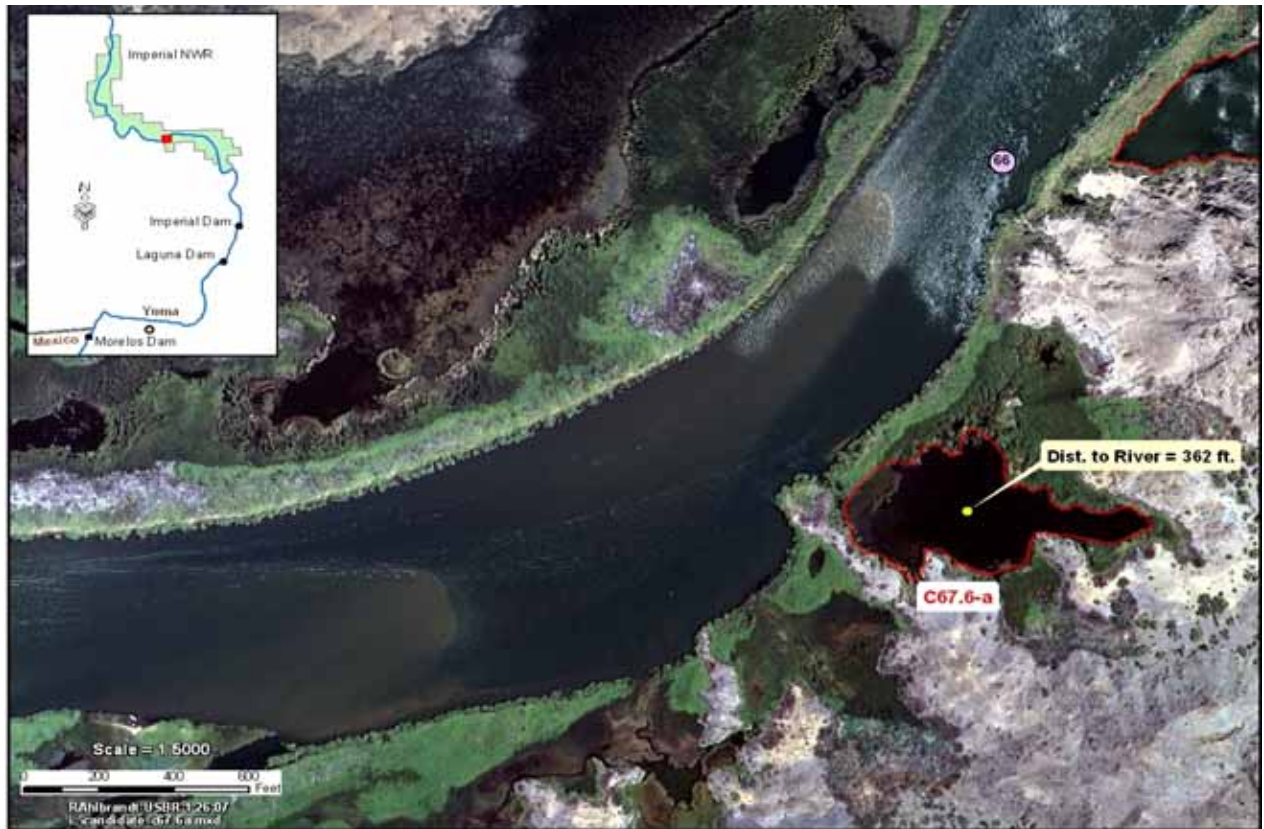
C67.6a is an indirectly connected backwater (4.1 ac) on the California side of the Colorado River at river mile 66.

Water quality in C67.6a was very similar to the Colorado River. Water clarity extended to the bottom. Because of the similarities in water quality without an observed connection to the river, C67.6a is classified as a pseudo-seep.

This backwater is isolated, virtually without access from the river or land. C67.6a is within a designated wilderness area, which would likely prevent the construction of any new roads for site access outside of the floodplain; heavy equipment access would be by river only. Public access is not restricted; however, no people were observed at C67.6a at the time of the helicopter survey.

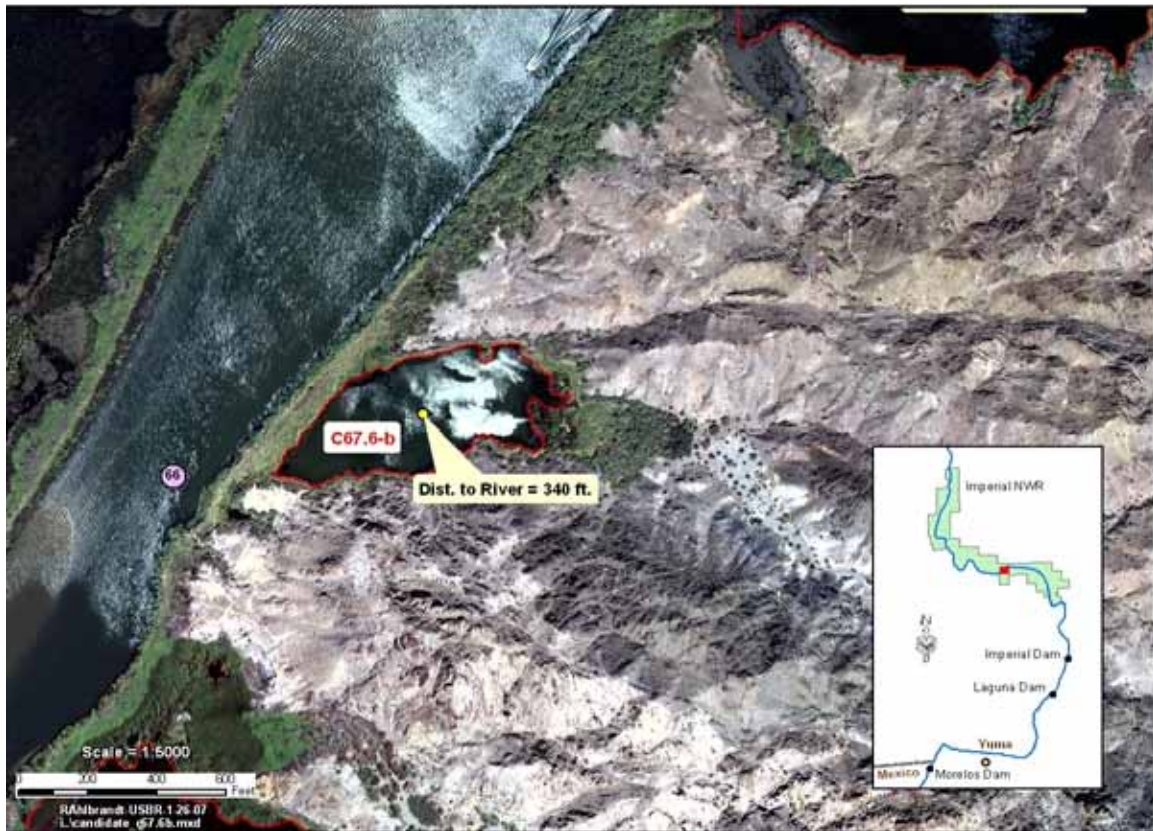
C67.6b is an indirectly connected backwater (4.7 ac) on the California side of the Colorado River at river mile 66.

Water quality in C67.6b is very similar to the Colorado River based on water quality profiles. Water clarity extended to the bottom. Because of the similarities in water quality without an observed connection to the river, C67.6b is classified as a pseudo-seep.

This backwater is isolated, virtually without site access by the river or by land. C67.6b is within a designated wilderness area, which would likely prevent the construction of any new roads for site access outside of the floodplain; heavy equipment access would be by river only. Public access is not restricted; however, no people were observed at C67.6b at the time of the helicopter survey.

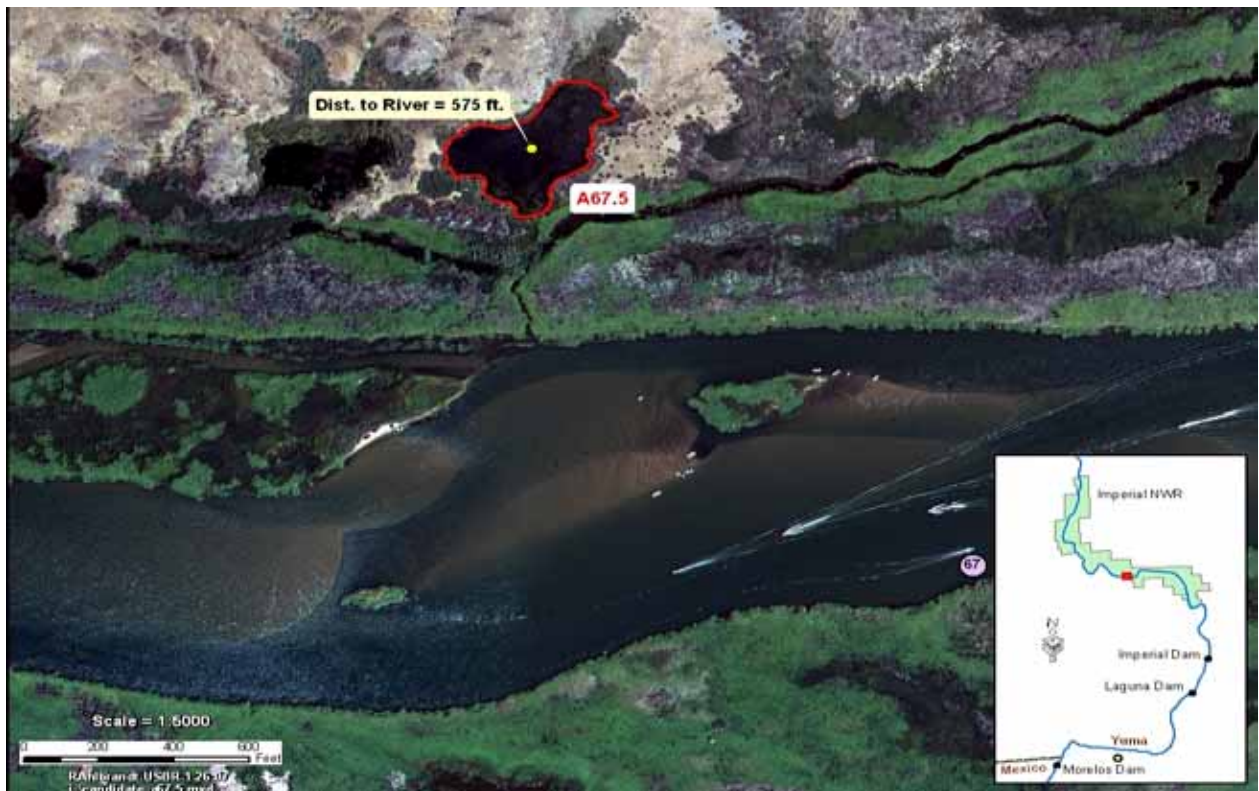
A67.5 is a directly connected backwater (2.3 ac) on the Arizona side of the Colorado River at river mile 67.5. The backwater is connected to Island Lake and the river via a small inlet channel, but it may be possible to isolate the backwater.

Water quality in A67.5 was very similar to the Colorado River based on water quality profiles. Water clarity was good to moderate. Because of the similarities in water quality, as well as the observed connection to the river, A67.5 is classified as a connected lake.

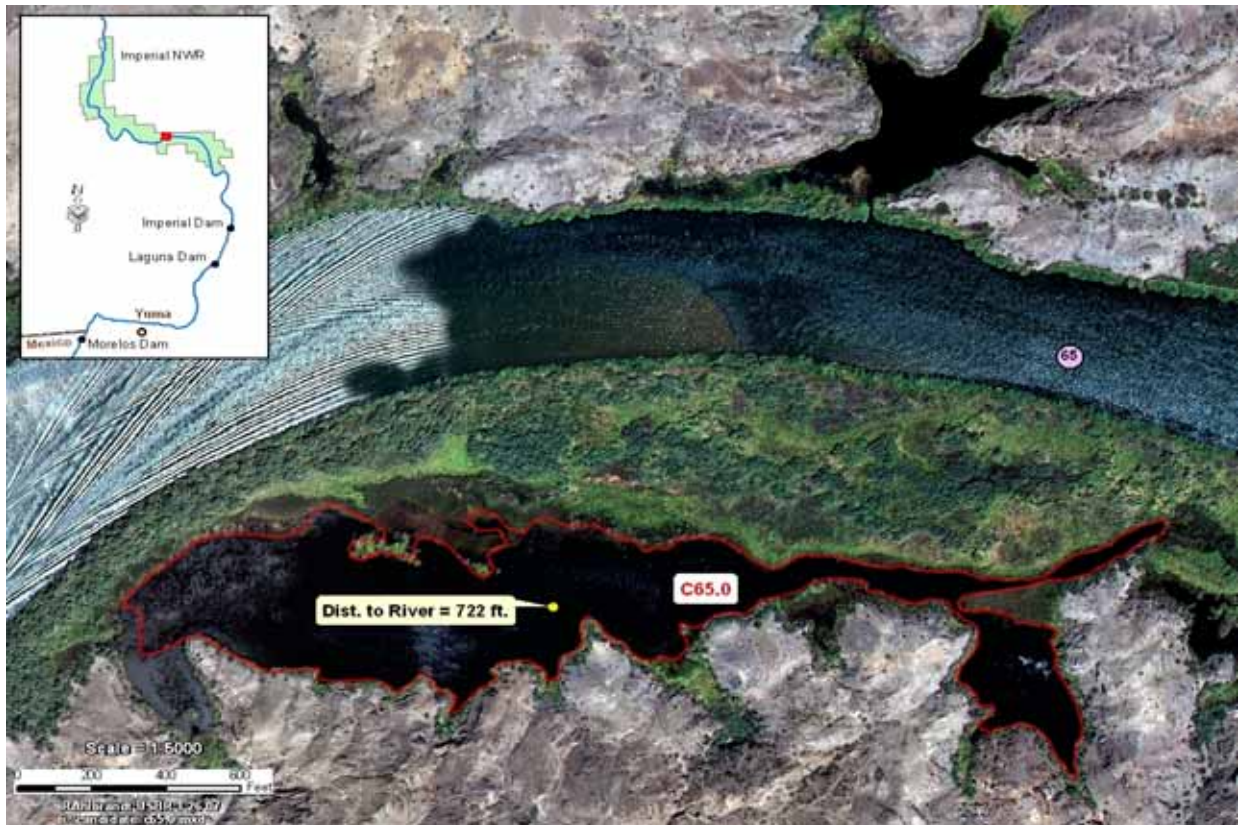
C65.0 is a directly connected backwater (17.6 ac) on the California side of the Colorado River at river mile 65. A smaller backwater exists nearby to the south, which could be connected for additional acreage or managed as separate backwater. C65.0 could potentially be isolated from the river.

Boat access from the river appears to exist at the south end of C65.0. Water clarity extended to the bottom, and depth appeared to be shallow (less than 5 feet). Because of the apparent connection to the river, as well as the high water clarity, water quality is likely very similar to the river. C65.0 is classified a connected lake. No water quality profiles were conducted at C65.0.

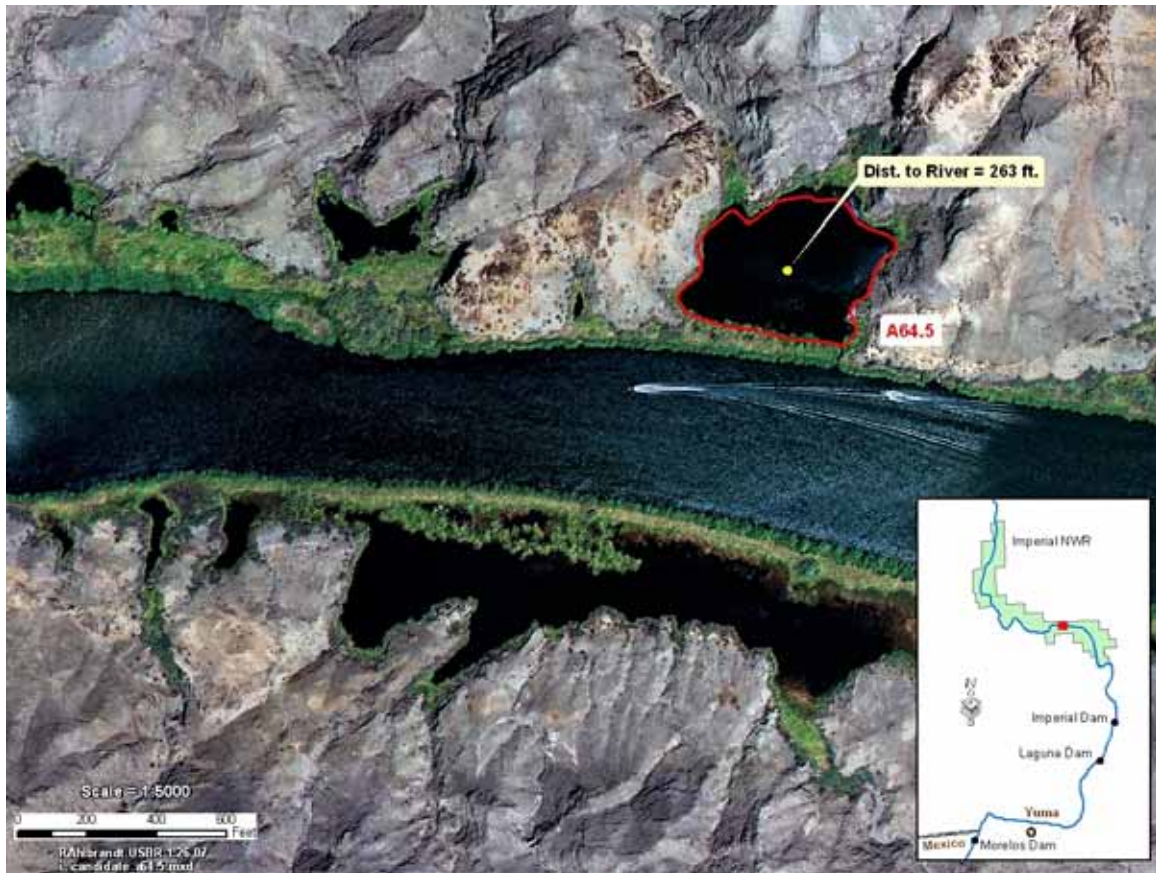
Lookout Lake is a directly connected backwater (4.1 ac) on the Arizona side of the Colorado River at river mile 64. Boat access from the river appears to exist, but the backwater could potentially be isolated from the river.

Water clarity at Lookout Lake extends to the bottom, which implies relatively good water quality. Because of the apparent connection to the river, as well as the high water clarity, water quality is likely very similar to the river. Lookout Lake is classified a connected lake. No water quality profiles were conducted at this backwater, only visual observations were made.

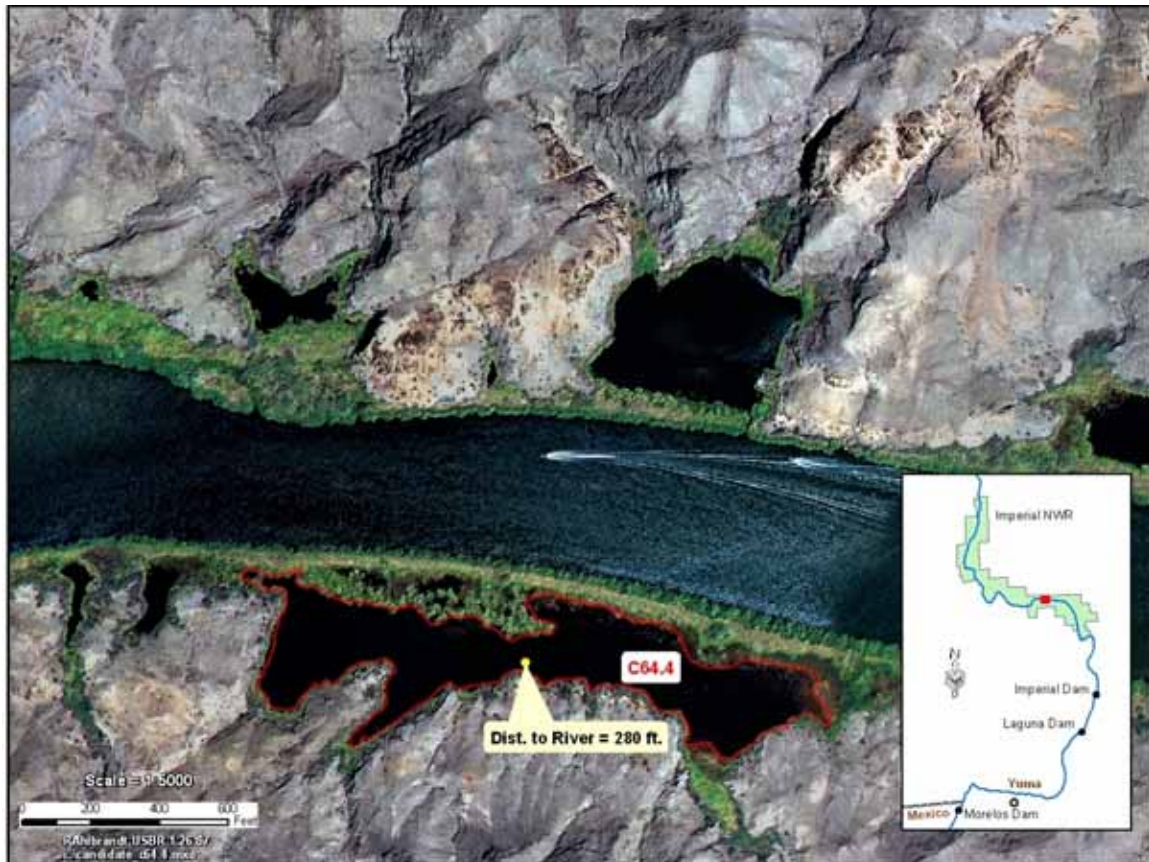
C64.4 is an indirectly connected backwater (8.4 ac) on the California side of the Colorado River at river mile 64.5. This backwater appears to be potentially accessible via a nearby road; however, no boat access to the river appears to exist.

Water quality at C64.4 was very similar to the Colorado River based on water quality profiles. Because of the high water quality, without an apparent surface connection to the river, this backwater is classified as a pseudo-seep.

C64.4 is within a designated wilderness area, which would likely limit the size of the construction footprint. However, the existence of a nearby road would improve access for heavy equipment. Public access is not restricted; however, no people were observed at C64.4 at the time of the helicopter survey.

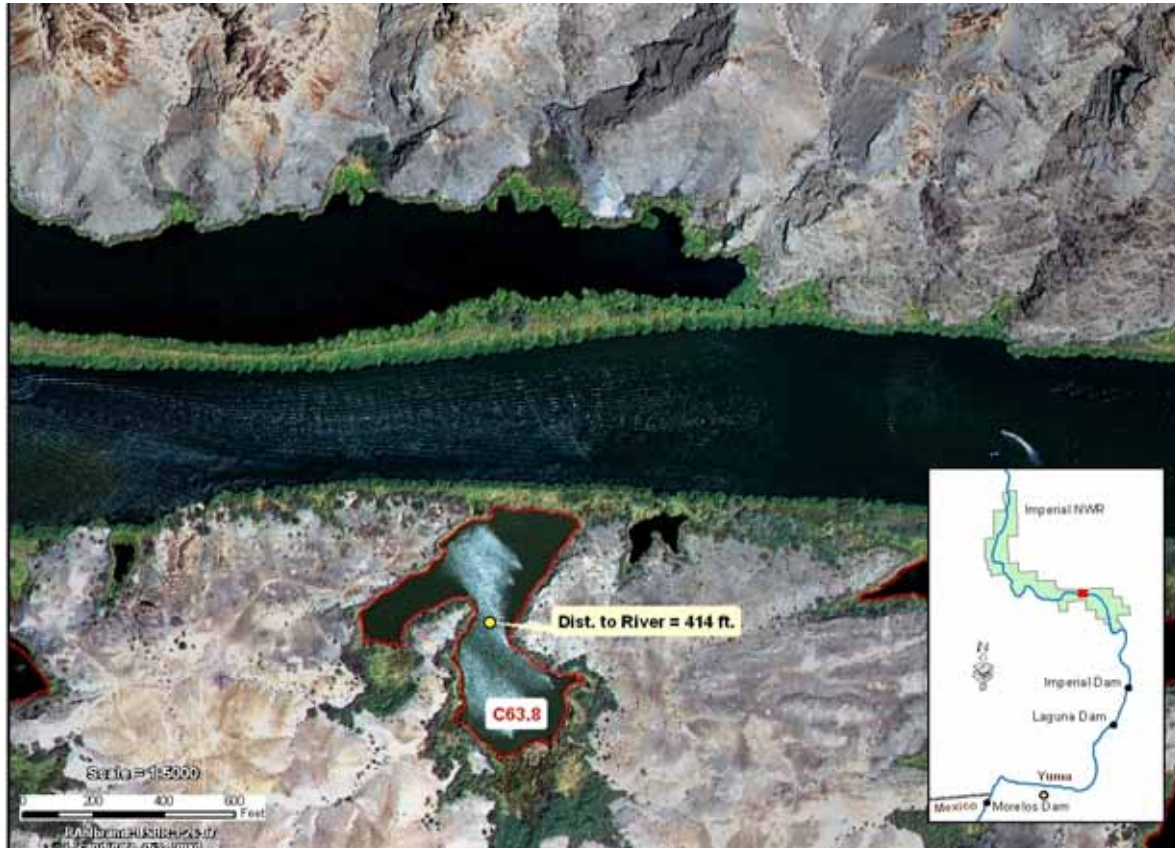
C63.8 is an indirectly<sup>2</sup> connected backwater (4.7 ac) located on the California side of the Colorado River at river mile 63.5. During the aerial survey, the backwater was 50% dry. This backwater is classified as a pseudo seep because while no visible surface connections to the river are visible; it most likely maintains close connection to the river during higher flows. The site is being considered as a candidate site due to possible expansion with an inflow and outflow channel to maintain permanence of water year-round.

Site access is limited to boating upriver and establishing a trail. C63.8 is within a designated wilderness area, which would likely prevent the construction of any new roads for site access outside of the floodplain; heavy equipment access would be by river only.

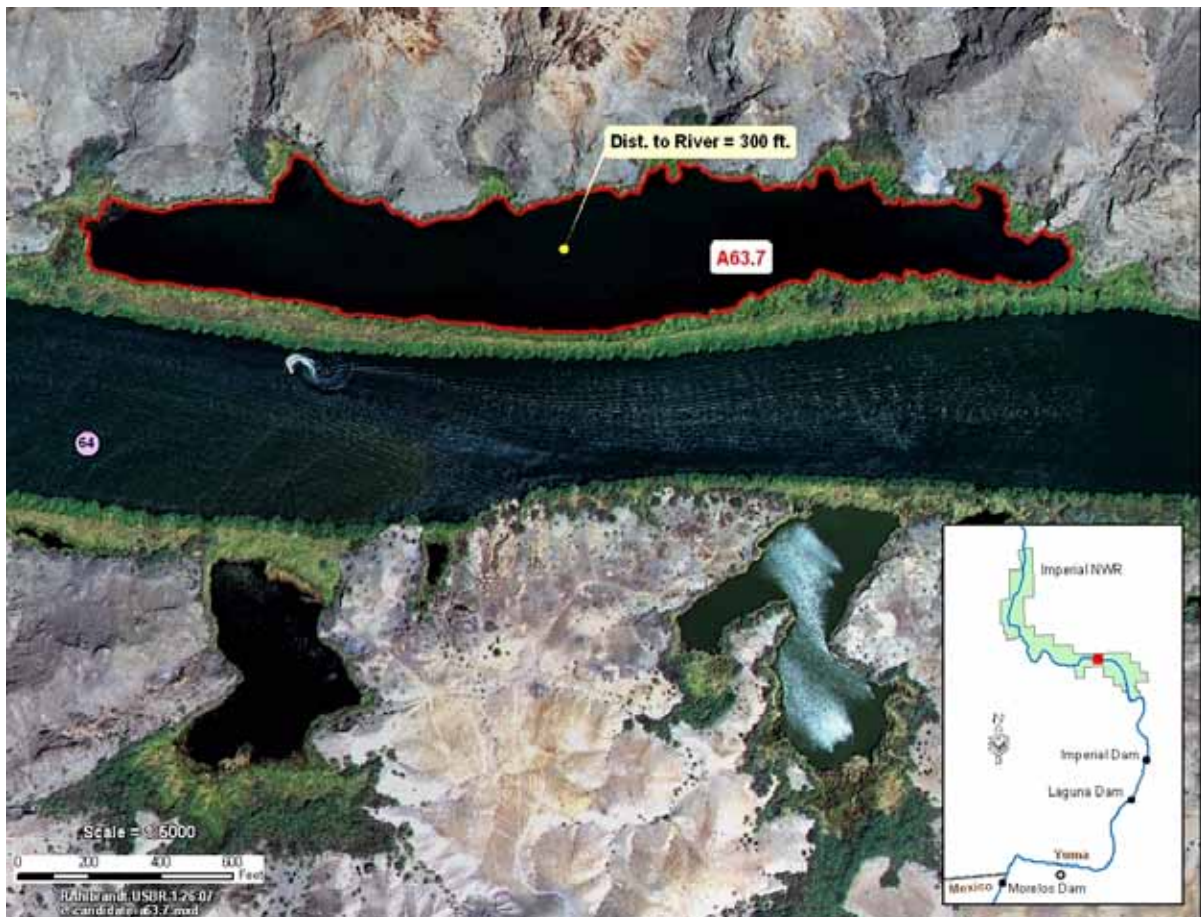
Cable Lake is a directly connected backwater (17.4 ac) on the Arizona side of the Colorado River at river mile 64. Boat access to Cable Lake from the river appears to exist, but the backwater could potentially be isolated from the river. Cable Lake is classified as a connected lake due to the surface connection to the river. Because of the apparent connection to the river, water quality is likely very similar to the river. No water quality profiles were conducted here at the time of the helicopter survey.

No road access was noted during the helicopter survey. Cable Lake is within a designated wilderness area, which would likely prevent the construction of any new roads for site access outside of the floodplain; heavy equipment access would be by river only. Public access is not restricted; however, no people were observed at Cable Lake at the time of the helicopter survey.

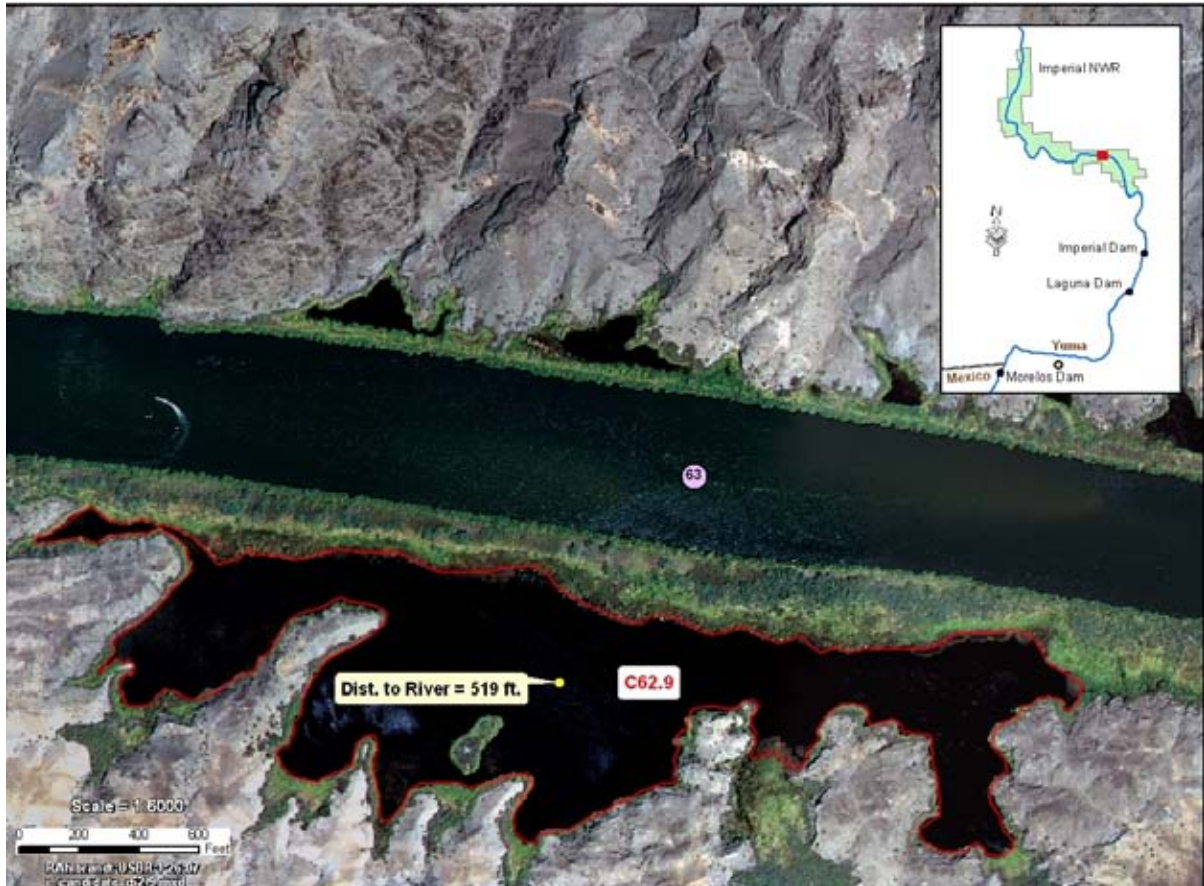
Duck Lake is an indirectly connected backwater (36.1 ac) on the California side of the Colorado River at river mile 63.

During the helicopter survey, it was observed that water exchange was present through the emergent vegetation. Due to water exchange through vegetation, Duck Lake is classified as a pseudo-seep, which would typically exhibit water quality similar to the river. Water clarity at Duck Lake was moderate.

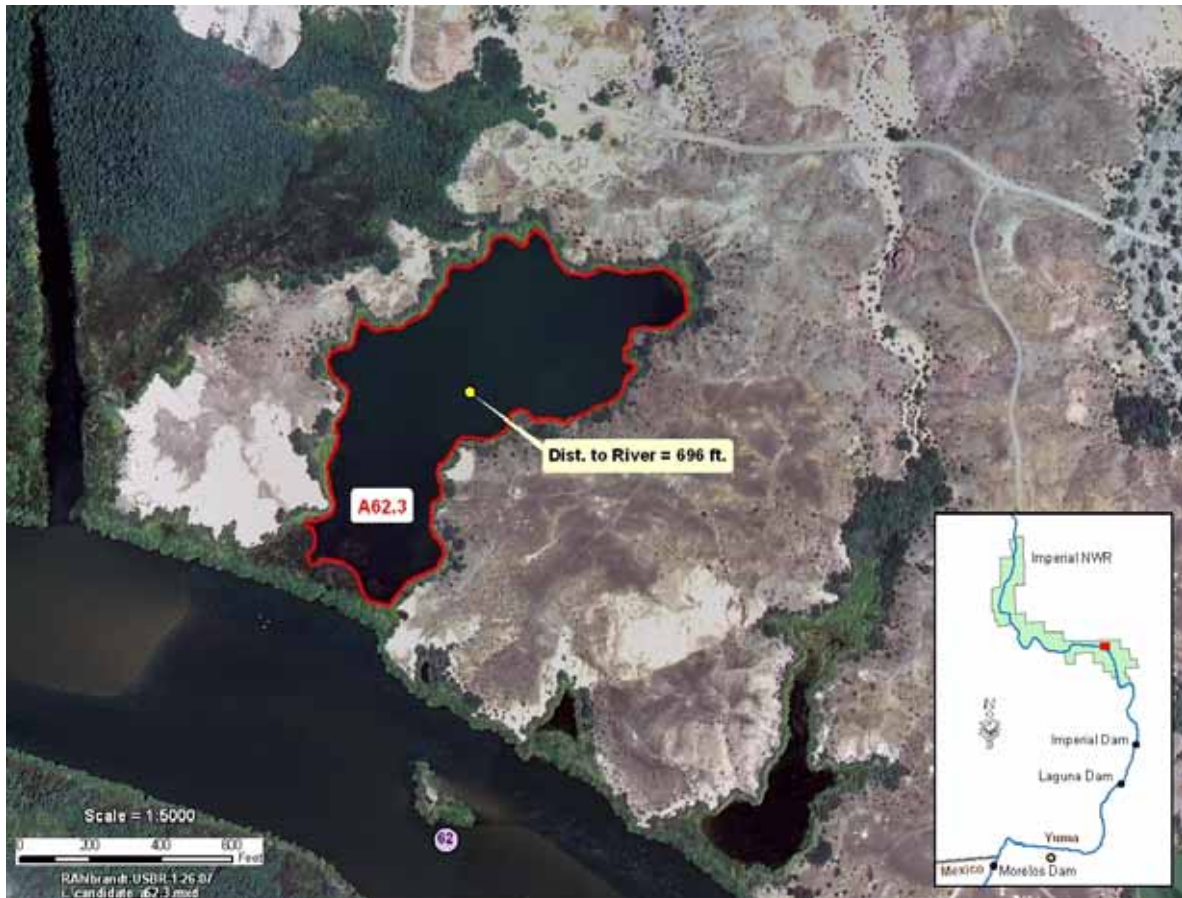
Secret Lake is a directly connected backwater (11.0 ac) on the Arizona side of the Colorado River at river mile 62. The backwater is connected to the river via a small inlet channel, accessible by very small boats (kayaks, canoes) only, but could potentially be isolated.

Water quality in Secret Lake is likely very similar to the Colorado River, due to the surface connection. Water clarity was moderate. Because of the presumed similarities in water quality, as well as the observed connection to the river, Secret Lake is classified as a connected lake.

In addition to boat access, there is a trail, which presumably connects to a nearby dirt road. Public access is not restricted; however, no people were observed at Secret Lake at the time of the helicopter survey.

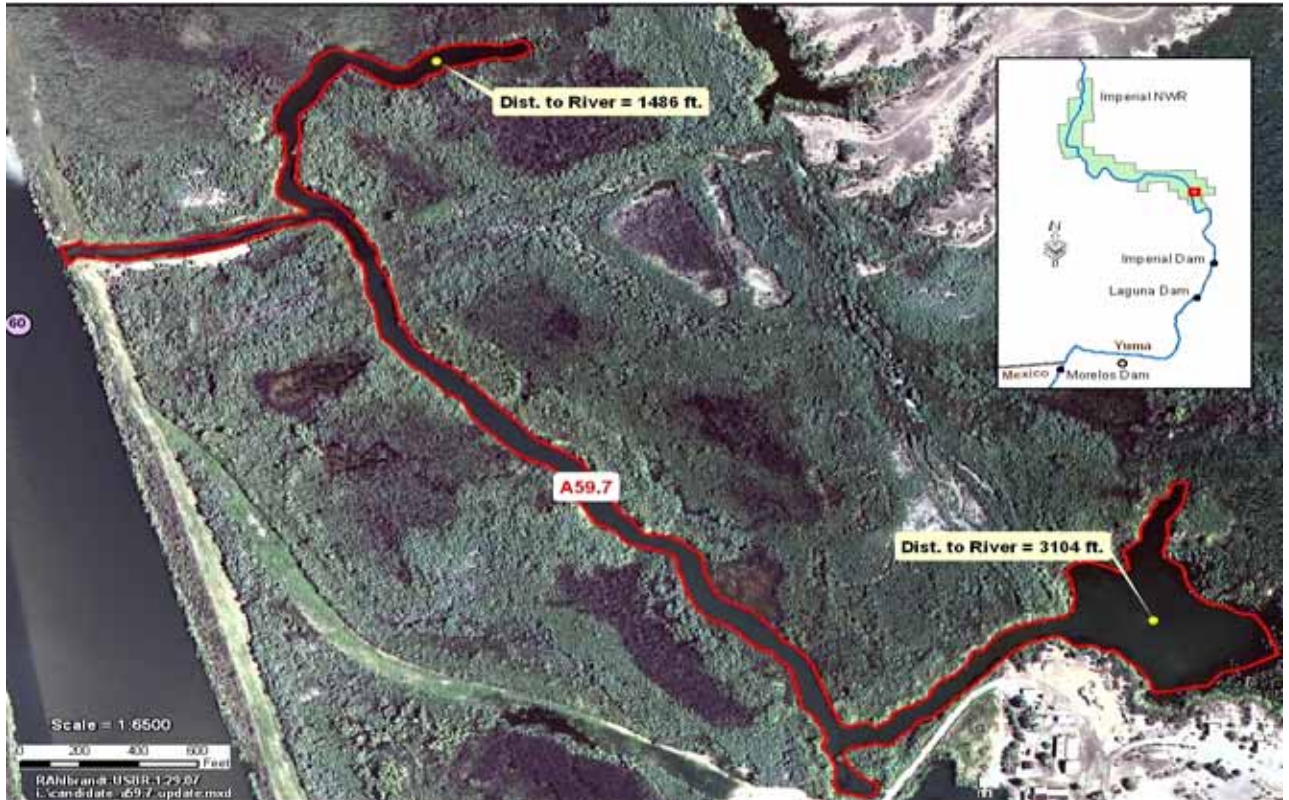
Headquarters Lakes consist of two directly connected backwaters (7 ac, 5 ac) on the Arizona side of the Colorado River at river mile 60. The backwaters are connected to the river via a dredged inlet canal, but it may be possible to isolate the backwaters.

Water quality in Headquarters Lakes was very similar to the Colorado River based on water quality profiles. Because of the similarities in water quality, as well as the observed connection to the river, Headquarters Lakes are classified a connected lakes.

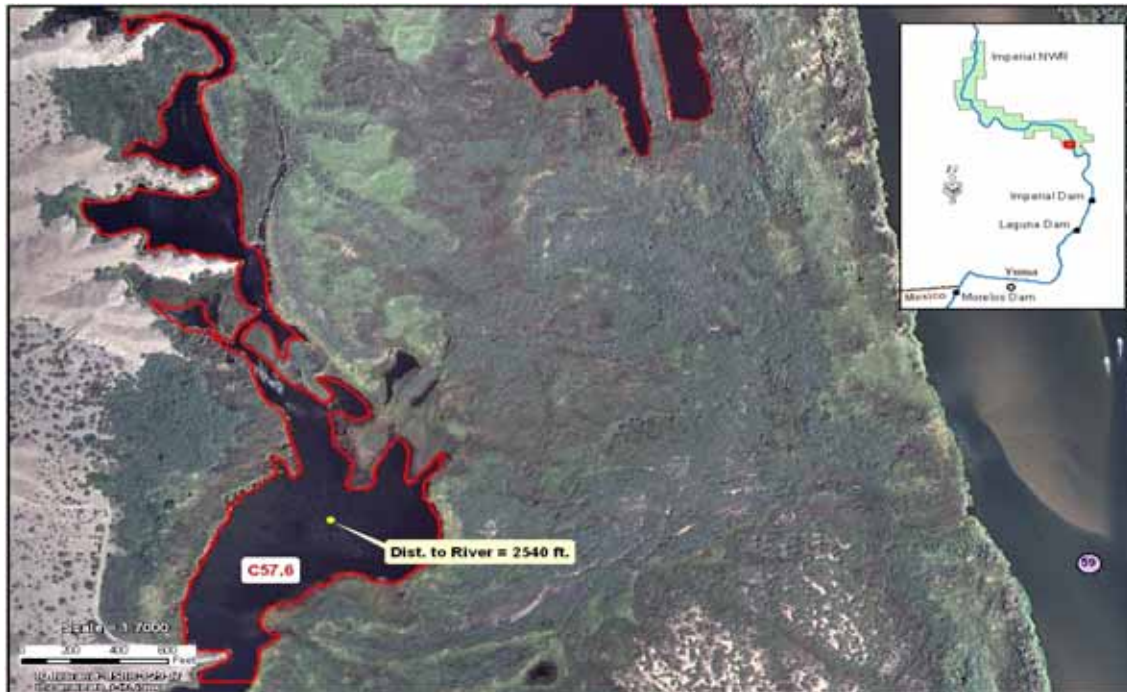
The upper end of Ferguson Lake contains an approximately 22-ac backwater area directly connected to the river at river mile 59.5. This location is closed to the public from November to April for waterfowl habitat. Water quality diminishes in the summer months presumably due to a lack of fresh water inflow into the upper end of the lake. Ferguson Lake is well connected, and is classified a connected lake.

Creating an isolated backwater habitat may entail isolating the northern part of the lake and creating an inflow from the river through the backwater lake complex to improve and maintain water quality.
